LandWater & Wool
Shaping the future

Rapid Appraisal of Riparian Condition Technical Guideline for the mid north of South Australia

Amy Jansen, Alistar Robertson, Leigh Thompson, Andrea Wilson and Kylie Nicholls

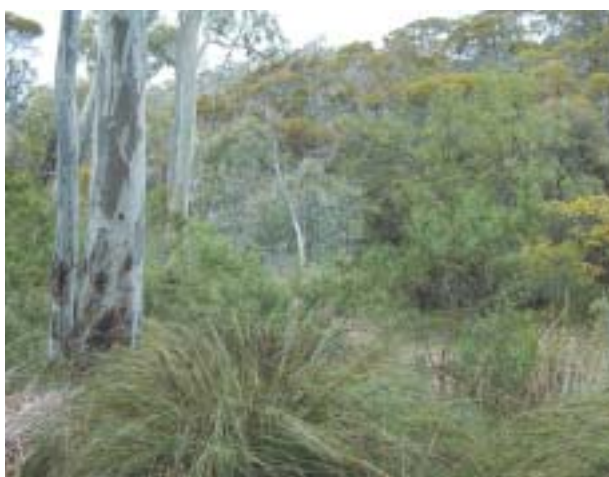
Photo 1. A site in good condition along the Hopkins Creek near Burra, South Australia (RARC score = 43; note continuous canopy of native trees, native shrub understorey, reeds and regeneration of canopy trees). Photo Kerri Muller.

Photos 1 and 2 show contrasting sites in good and very poor condition in the mid north of South Australia. Details of the scoring for these sites can be found in the box below.

Example of scoring indicators for the sites shown in Photos 1 and 2 (see Table 2 for indicators and details)				
Sub-index	Good condition site (Photo 1)		Very poor condition site (Photo 2)	
Habitat	4 + 4 + 3 =	11	0 + 0 + 2 =	2
Cover	3 + 3 + 3 + 3 =	12	0 + 1 + 3 + 2 =	6
Natives	3 + 3 + 2 =	8	0 + 1 + 1 =	2
Debris	2 + 2 + 0 + 1 + 1 =	6	2 + 1 + 0 + 0 + 0 =	3
Features	2 + 2 + 1 + 1 =	6	0 + 1 + 0 + 0 =	1
Total		43		14

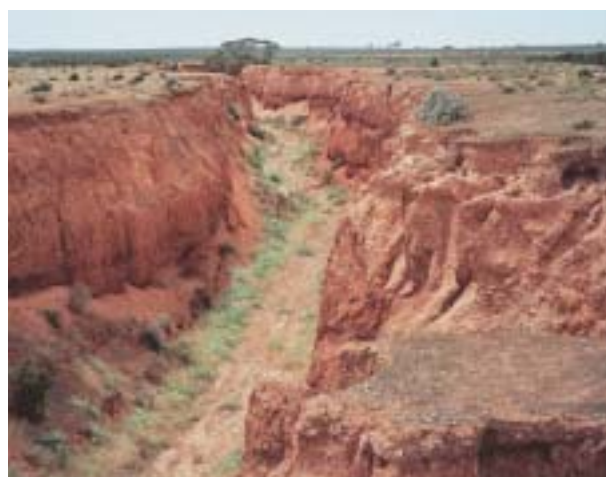
Photo 2. A site in very poor condition in the mid north of South Australia (RARC score = 14; note lack of canopy cover, little shrub cover and small amounts of leaf litter). Photo Phil Price.

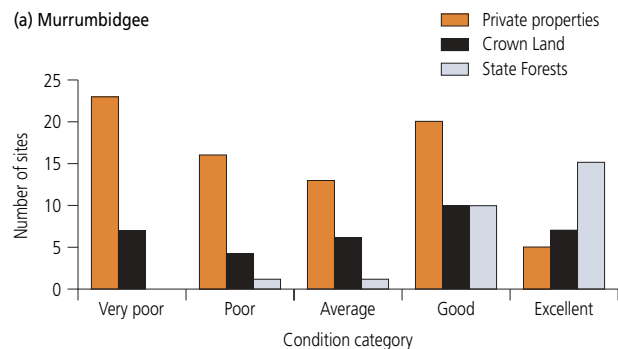
Figure 2. The number of sites scoring in each category (< 25 very poor, 25–30 poor, 30–35 average, 35–40 good and > 40 excellent) of the RARC index for three regions: (a) Murrumbidgee River, (b) West and South Gippsland, and (c) upper and mid-Goulburn-Broken catchment.

A total of 138 sites (each 1 kilometre in length) were surveyed between Gundagai and Hay, on private properties, crown land and State Forests (Jansen & Robertson, 2001a). The majority of sites on private property were in very poor condition, while sites on Crown Land (mainly Travelling Stock Reserves) were very variable. Most State Forest sites were in good to excellent condition (Figure 2a).

A total of 108 sites (each 150 metres in length) were surveyed in West and South Gippsland, at three types of sites — grazed paddocks on private properties, planted and fenced riparian areas on private properties, and remnant patches of uncleared native vegetation both on private properties and in reserves (Thompson et al., 2003). All private property sites were on dairy farms. The majority of sites were in very poor condition, with only remnant sites scoring above average (Figure 2b). It should be noted that most planted sites were relatively recently fenced, and their condition can be expected to improve as the plantings mature.

A total of 46 sites (each 200 metres in length) were surveyed in the upper and mid-Goulburn-Broken catchment, at grazed and ungrazed sites on private properties, and at ungrazed sites in reserves (Wilson et al., 2003). Again, the majority of sites were in very poor condition (Figure 2c). Like the Gippsland planted sites, many of the Goulburn-Broken ungrazed sites on private properties were relatively recently fenced, and their condition can be expected to improve as plantings mature.

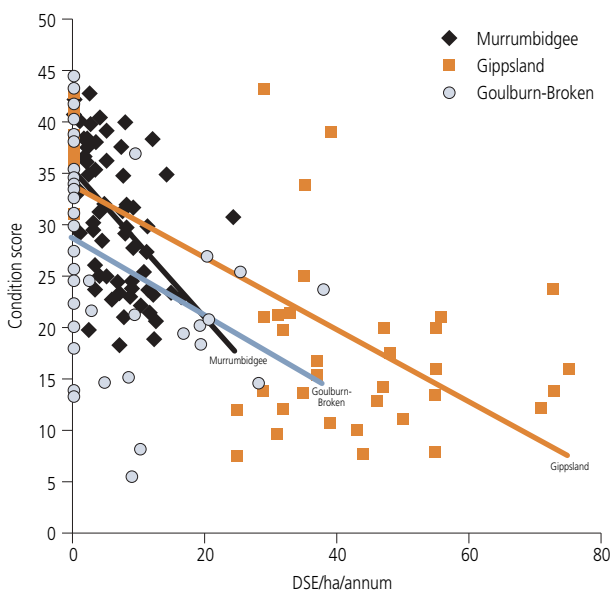
Figure 3. RARC condition scores in relation to stocking rates (DSE/ha/annum) for three regions: Murrumbidgee River, West and South Gippsland, and upper and mid-Goulburn-Broken catchment.

In all three regions, we examined the relationship between stocking rates and riparian condition, with Figure 3 below showing our results. Clearly, riparian condition declined with increased stocking rates, across all regions and a large range of stocking rates. Given the large number of sites in poor condition in all catchments, this suggests that with current management, stocking rates commonly used on private properties are too high to maintain riparian zones in good condition.

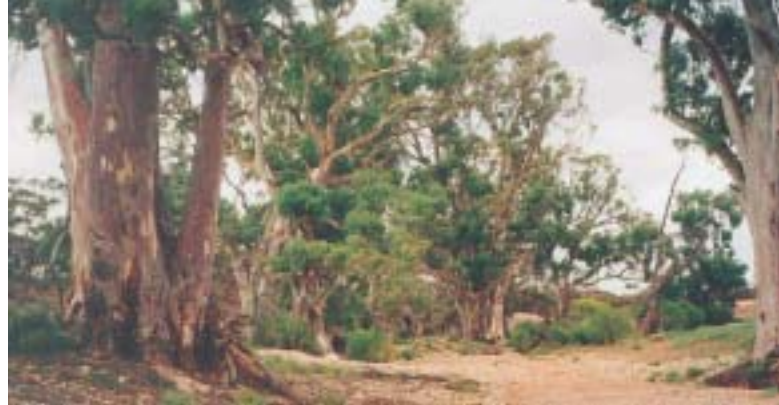
Photo: This was one of the highest scoring grazed sites in the Burra survey for riparian condition. Photo Kylie Nicholls.

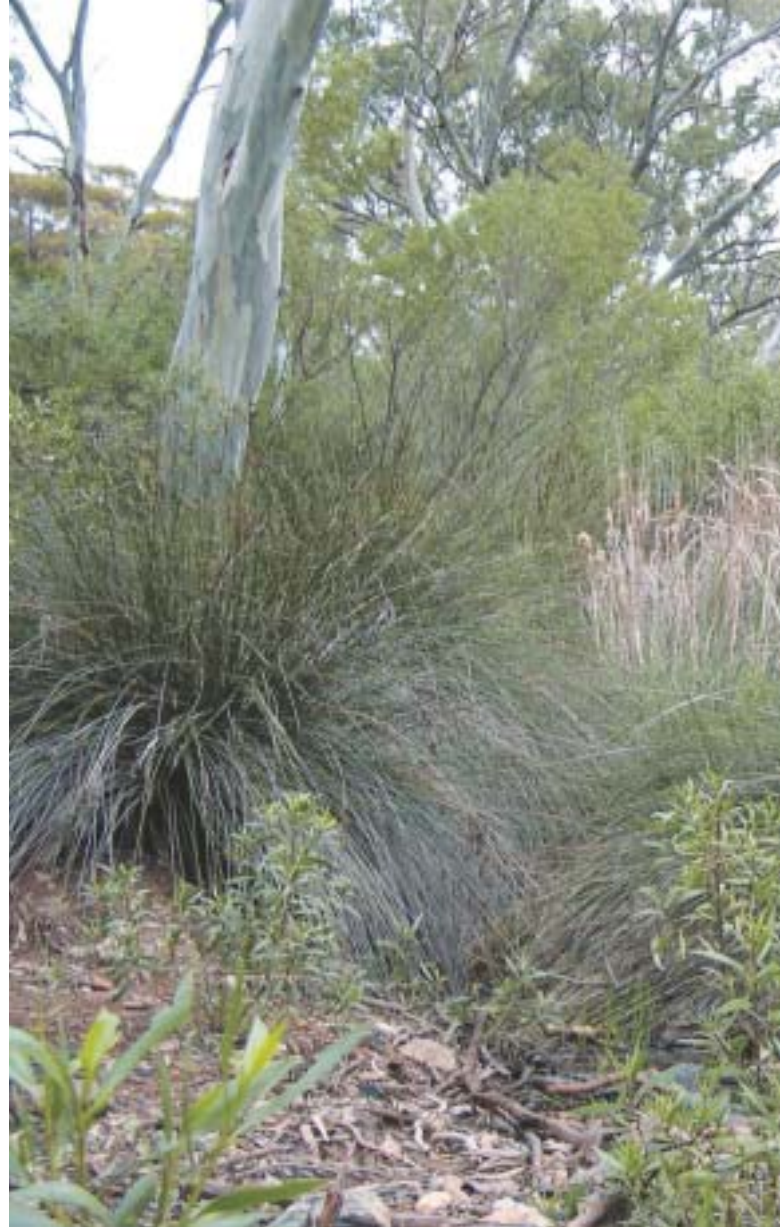
Above: Healthy riparian area with a diversity of vegetation providing habitat for both aquatic and terrestrial animals, Hopkins Creek, South Australia. Photo Kerri Muller.

Right: A brown treecreeper. These birds live in riparian areas and their presence can be used as an indicator of riparian health. Photo Andrew Tatnell.

(scoring for leaf litter, fallen logs and standing dead trees), indicating that retention of leaf litter and woody debris in riparian habitats is crucial to the survival of riparian bird communities. Many of the species most dependent on these features (for example, brown treecreepers) are threatened or declining throughout the agricultural regions of southern Australia (Ford et al., 2001).

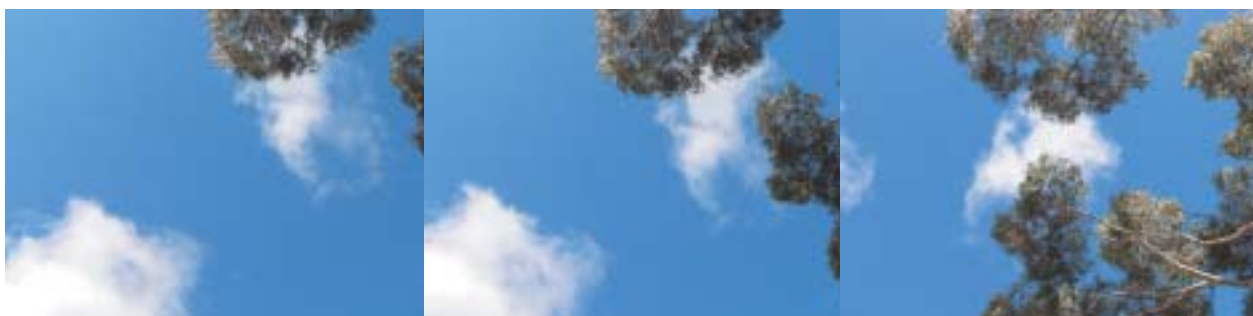
Photo 3. Canopy cover increasing from 1 to 3 (left to right). Photos Kylie Nicholls.

COVER (see Photo 3 below)

Canopy cover (trees > 4 m tall): 0 = none,
1 = 1–5%, 2 = 6–30%, 3 = > 30%

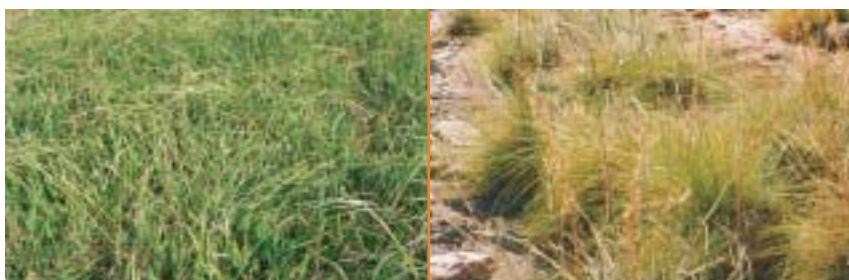
Tussocky perennial (long-lived) grasses tend to be native species while annual (short-lived) grasses tend to be exotic species (with a few obvious exceptions such as *Phalaris* which is a perennial exotic species).

Photo 4. Exotic annual ground cover (left) versus native perennial tussock ground cover (right). Photos Kylie Nicholls.

NATIVES (see Photo 4 overleaf)

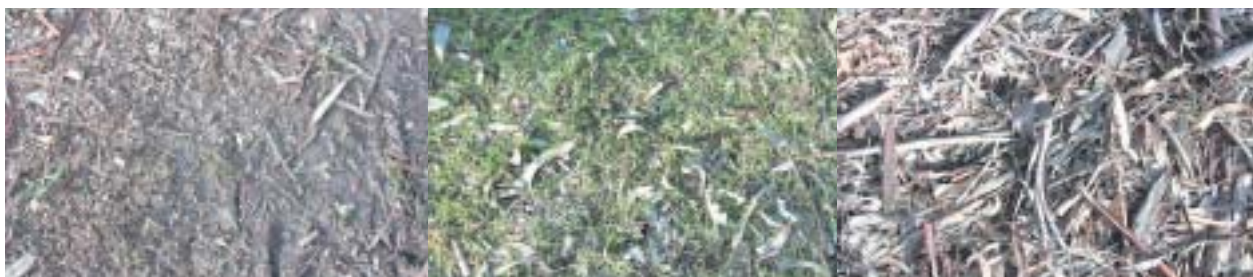
Photo 5. Leaf litter cover increasing from 1 to 3 (left to right). Photos Amy Jansen.

DEBRIS (see Photo 5 above)

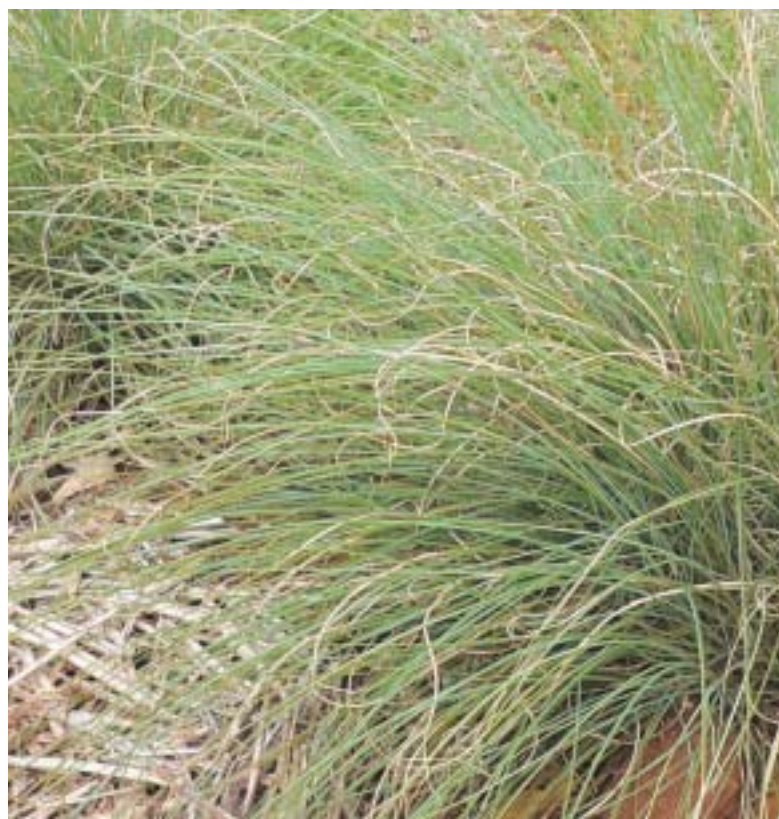
Photo 6 (below). *Cymbopogon ambiguus* (lemon grass) is a tall, summer growing perennial grass with blue-green leaves which smell strongly of citronella when crushed. In the mid north it is commonly found in creek beds and along riparian areas. It is generally not grazed by livestock. Photo Kylie Nicholls.
